Bulletin: CLIB-0004

Topic: Heavy Duty Clutch Fails to Disengage (Broken Pivot Bolt)

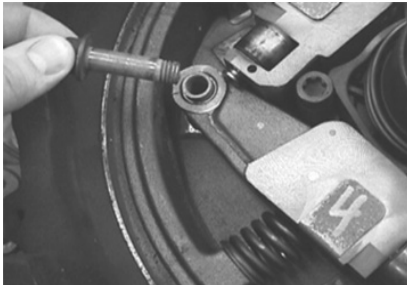
Complaint of transmission will not engage in a gear from neutral and / or truck has urge to move at idle. Clutch data max energy is less than 3000 BTU and no indication of secondary failure. (i.e. FC 16, 35,93). Return material findings, flyweight pivot bolt breaking where the threaded portion of bolt passes through the pivot point.
